Liquefied petroleum gas plant maintenance: a case study of gangway failure analysis

Proceedings of the 16th International Conference on Condition Monitoring and Asset Management, BINDT 2019

Liquefied Petroleum Gas Plant Maintenance: A case study of Gangway failure analysis

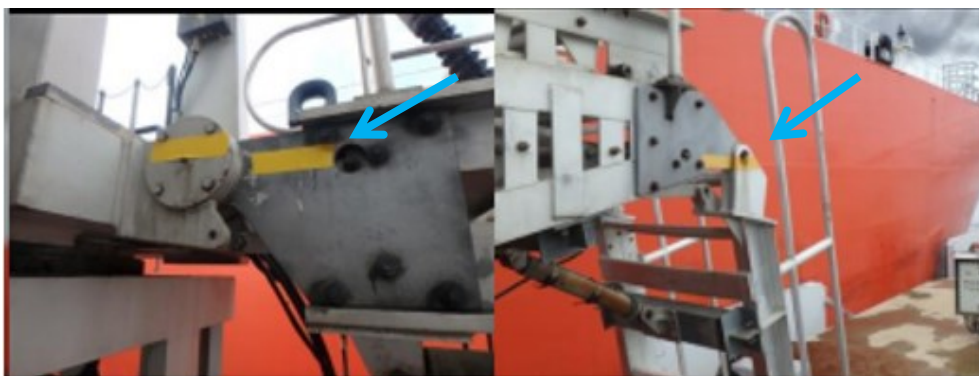
Root cause analysis of the cable is conducted and the failure modes leading to cable failure is caused by twisted cable when the gangway is moving down to a parking position. The observed incident is as a result of the following;

- I. Cable replacement with a different cable size with larger diameter
- II. Safety pin not extracted fully which cause the platform to jam

Figure 4 Gangway structure at parking position

Carry out visual inspection prior to starting up the Gangway, check the steel wire condition, pulley block, and direction of pump motor rotation. Alignment marks for the fixed ladder position to the rotating platform as shown in the diagram below in Figure 4. The yellow mark will ensure that the hydraulic motor stop by the set point.

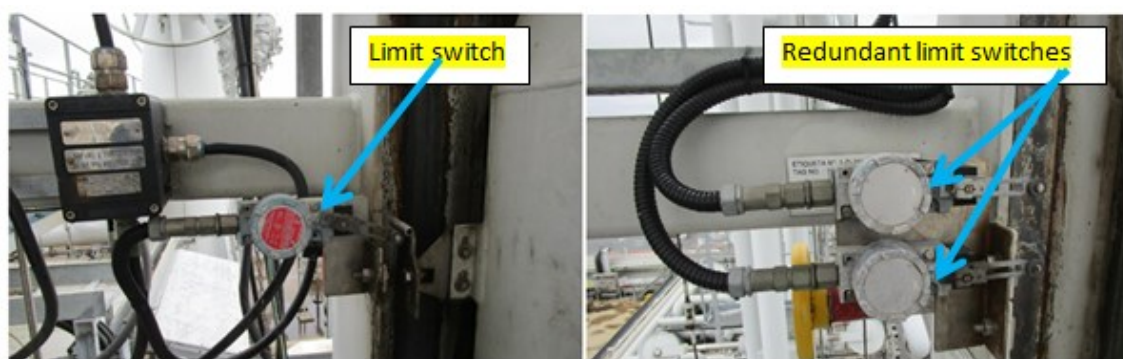
The gangway tower has a single limit switch installed at level 1 of the tower to prevent the gangway from continuing to unspool cable when the gangway reaches level 1 Figure 1. If the lower limit switch fails to activate this could lead to an unsafe condition. The investigation conducted indicates that the incident was not due to a limit switch issue and was instead caused because the gangway was not centered and was resting on the sides of the parking stands causing it to not reach the lower limit switch. However, upon review of the installation it was observed that a backup lower limit switch is required to ensure that the switch functions properly to prevent potential safety hazards. The installation has redundant limit switches at the top level 5 as shown in Figure 6 below.

Figure 6 Single limit switch at Level 1, and redundant limit switch at level 5

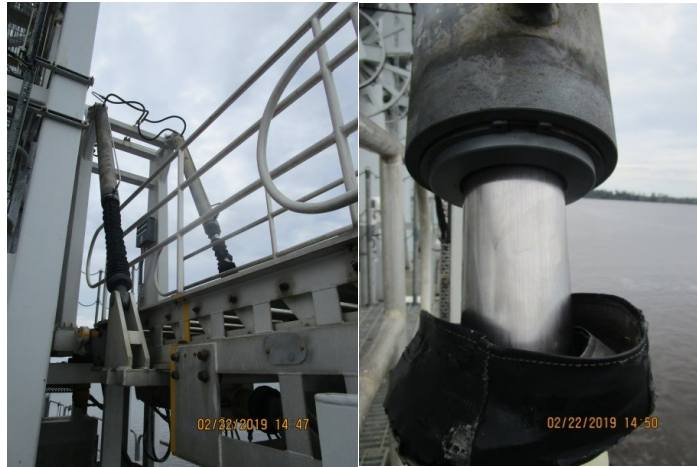
Oil leak on hydraulic ram cylinder (luffing cylinder) was investigated and we found the first seal failure as shown in the diagram in Figure 8, the possible causes of failure is as result of;

- Ageing process, seals are expected to be used until the end of useful life time.
- Seal was not replaced since the plant start-up, nor replaced when mechanics identified the oil dripping issue.

- There was no preventive maintenance in place to replace the internal parts (seals) of the hydraulic cylinder.

Figure 8 hydraulic ram cylinder oil leak (seal failed)
